**Flood Control Project Maintenance  
Levee Inspections**

## Maintenance Issue Types Only, Levee Inspection Report By Mile - Spring 2017

### Knights Landing Ridge Drainage District

Waterway	Bank	Unit Miles	Inspection Start/End	Inspector
Unit No. 01 Knights Landing Ridge Cut	Right	6.36	05/02/2017 05/02/2017	Zach Jojola

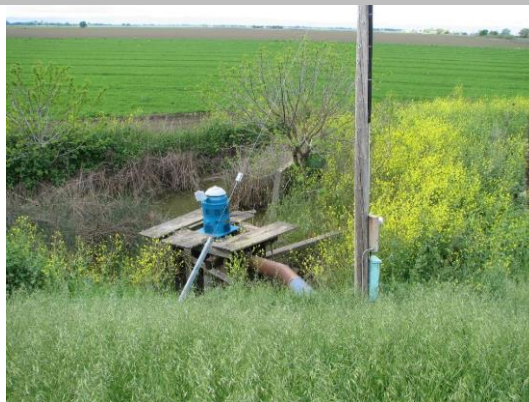
Photo 1 of 1 : UCIP\_SP\_2017\_11067\_18431.jpg

LM Start	2.58	Rating **	M	Issue No.	44
LM End	2.58	Issue Type +	Ma	Location *	LS
Category	Supplemental			GPS Latitude/Longitude	
				Start	End
Item	DWR UCIP LMA Responsibility			38.747110 °	38.747110 °
				-121.694415 °	-121.694415 °
DWR ID					
Comment Code					
Inspector Comment					
FS_ID:11067 DS_ID:19364 EP_NO: 9307 Repair Type: Non-Urgent Crossing Status: Found UCIP Comments: Siphon breaker on LS burried or broken off and missing. FIELD_STRUCT_DESC: 1 of 2: 14-inch pipe through the levee, 5.4-feet below crown. Pump house on pile structure at the landward toe Siphon breaker on the landward slope. Service pole and anchor at landward toe (Permit No. 9307- Lowe). Originally included in O+M manual (1953). FS Date: 4/5/2013

Pump and pipe on LS toe.

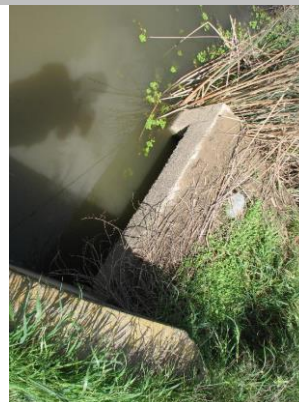
Photo 2 of 3 : UCIP\_SP\_2017\_13205\_21601.jpg

FS\_ID:13205  
DS\_ID:19391  
EP\_NO: 9307  
Repair Type: Non-Urgent  
Crossing Status: Found  
UCIP Comments: Walkway to actuator slide gate is missing. No method of actuating slide gate.  
FIELD\_STRUCT\_DESC: 2 of 2: 4-foot x 4-foot concrete box culvert through the levee, 23 feet below the crown. Walkway to slide gate on the waterside end, concrete headwalls on both ends. Service pole and anchor at landward toe. Concrete headwalls on both ends (Permit No. 9307- Lowe).  
FS Date: 4/5/2013

Concrete inlet on LS toe.

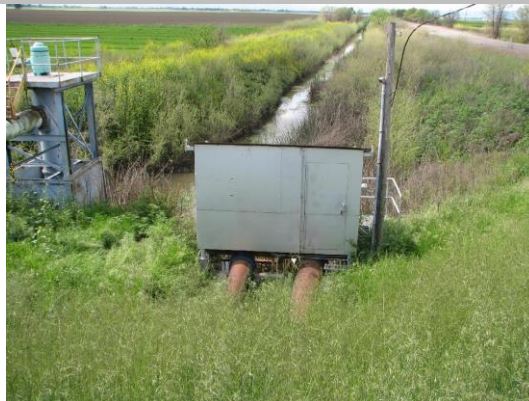
Photo 2 of 3 : UCIP\_SP\_2017\_16105\_27209.jpg

FS\_ID:16105  
DS\_ID:19365  
EP\_NO: 9301  
Repair Type: No Action Needed  
Crossing Status: Found  
UCIP Comments:  
FIELD\_STRUCT\_DESC: 1 of 2: 18-inch pipe through the levee 6.4-feet below the crown. Siphon breaker on the waterside slope. Pump house mounted on concrete box in irrigation ditch at the landward toe. (Permit No. 9301-RD 730). Originally included in O+M manual (1953).  
FS Date: 4/5/2013

Pumphouse and pipe on LS toe.

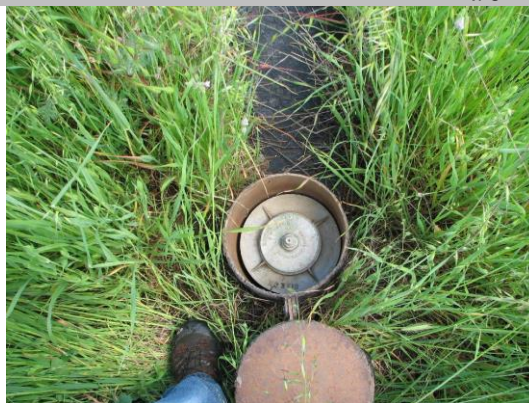
Photo 3 of 3 : UCIP\_SP\_2017\_16105\_27210.jpg

Siphon breaker on WS slope.

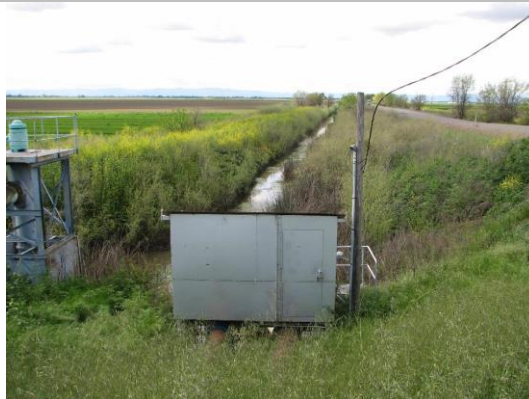
Photo 1 of 3 : UCIP\_SP\_2017\_16106\_27213.jpg

FS\_ID:16106  
DS\_ID:19392  
EP\_NO: 9301  
Repair Type: No Action Needed  
Crossing Status: Found  
UCIP Comments:  
FIELD\_STRUCT\_DESC: 2 of 2: 24-inch pipe through the levee 7.3-feet below the crown. Pump house mounted on concrete box in irrigation ditch at the landward toe. Siphon breaker in riser on WS slope. (Permit No. 9301-RD 730). Originally included in O+M manual (1953).  
FS Date: 4/5/2013

Pumphouse and pipe on LS toe.

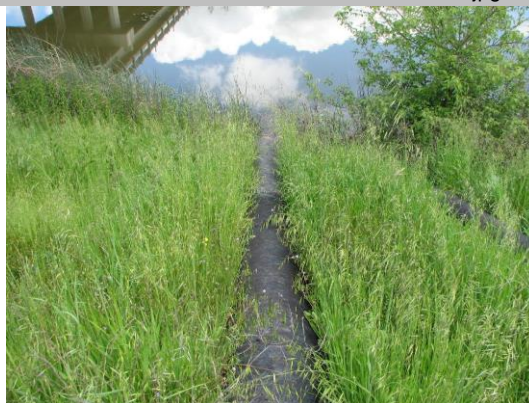
Photo 3 of 3 : UCIP\_SP\_2017\_16106\_27214.jpg

LM Start	2.67	Rating **	A/W	Issue No.	47 (cont)
LM End	2.67	Issue Type +	Ma	Location *	LS
Category	Supplemental			GPS Latitude/Longitude	
				Start	End
Item	DWR UCIP LMA Responsibility			38.748404 °	38.748404 °
				-121.694818 °	-121.694818 °
DWR ID					
Comment Code					
Inspector Comment					
FS_ID:16106					
DS_ID:19392					
EP_NO: 9301					
Repair Type: No Action Needed					
Crossing Status: Found					
UCIP Comments:					
FIELD_STRUCT_DESC: 2 of 2: 24-inch pipe through the levee 7.3-feet below the crown. Pump house mounted on concrete box in irrigation ditch at the landward toe. Siphon breaker in riser on WS slope. (Permit No. 9301-RD 730). Originally included in O+M manual (1953).					
FS Date: 4/5/2013

Pipe on WS slope.

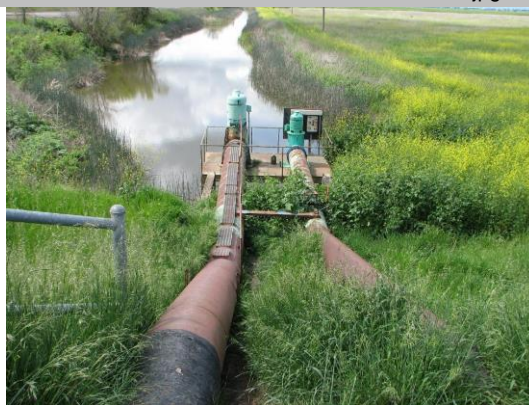
Photo 1 of 2 : UCIP\_SP\_2017\_11244\_18603.jpg

LM Start	2.70	Rating **	A/W	Issue No.	49
LM End	2.70	Issue Type +	Ma	Location *	LS
Category	Supplemental			GPS Latitude/Longitude	
				Start	End
Item	DWR UCIP LMA Responsibility			38.748909 °	38.748909 °
				-121.694811 °	-121.694811 °
DWR ID					
Comment Code					
Inspector Comment					
FS_ID:11244					
DS_ID:19394					
EP_NO: 8752					
Repair Type: No Action Needed					
Crossing Status: Found					
UCIP Comments:					
FIELD_STRUCT_DESC: 1 of 2: 30-inch steel asphalt coated storm drain pipe through the levee 3.0-feet below the crown. Siphon breaker on pipe WS shoulder and a pump on a steel pile structure at the LS toe. Some design drawings available. (Permit No. 8752, 1973)					
FS Date: 4/5/2013

Pump on steel pile structure at LS toe with pipe on slope.

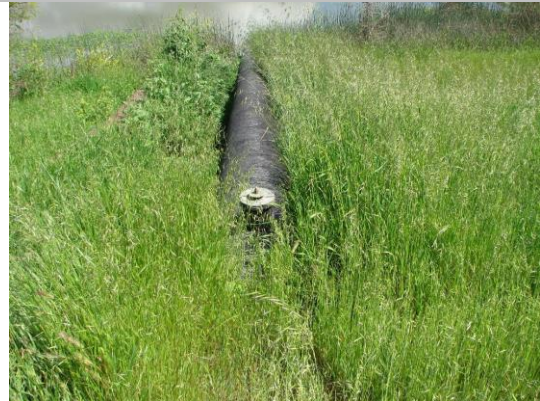
Photo 2 of 2 : UCIP\_SP\_2017\_11244\_18602.jpg

LM Start	2.70	Rating **	A/W	Issue No.	49 (cont)
LM End	2.70	Issue Type +	Ma	Location *	LS
Category	Supplemental			GPS Latitude/Longitude	
				Start	End
Item	DWR UCIP LMA Responsibility			38.748909 °	38.748909 °
				-121.694811 °	-121.694811 °
DWR ID					
Comment Code					
Inspector Comment					
FS_ID:11244 DS_ID:19394 EP_NO: 8752 Repair Type: No Action Needed Crossing Status: Found UCIP Comments: FIELD_STRUCT_DESC: 1 of 2: 30-inch steel asphalt coated storm drain pipe through the levee 3.0-feet below the crown. Siphon breaker on pipe WS shoulder and a pump on a steel pile structure at the LS toe. Some design drawings available. (Permit No. 8752, 1973) FS Date: 4/5/2013

Siphon breaker on pipe at WS slope.

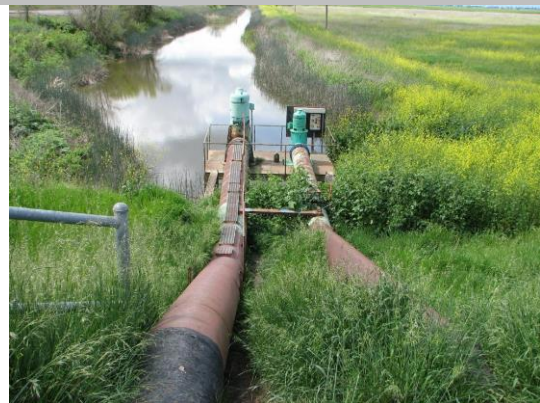
Photo 1 of 2 : UCIP\_SP\_2017\_11247\_18605.jpg

LM Start	2.71	Rating **	A/W	Issue No.	50
LM End	2.71	Issue Type +	Ma	Location *	LS
Category	Supplemental			GPS Latitude/Longitude	
				Start	End
Item	DWR UCIP LMA Responsibility			38.748929 °	38.748929 °
				-121.694749 °	-121.694749 °
DWR ID					
Comment Code					
Inspector Comment					
FS_ID:11247 DS_ID:19395 EP_NO: 8752 Repair Type: No Action Needed Crossing Status: Found UCIP Comments: FIELD_STRUCT_DESC: 2 of 2: 24-inch pipe through the levee 3.0-feet below the crown. Siphon breaker on pipe on WS shoulder with a pump on a steel pile structure at the LS toe. Butterfly shutoff valve at LS toe. Some design drawings available. (Permit No. 8752, 1973). FS Date: 4/5/2013

Pump on steel pile structure with butterfly valve and pipe on LS slope.

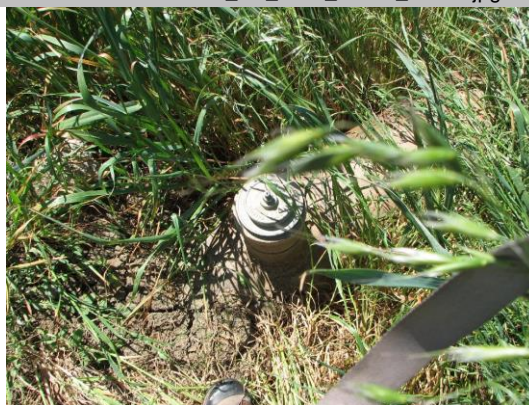
Photo 3 of 3 : UCIP\_SP\_2017\_11293\_18673.jpg

FS\_ID:11293  
DS\_ID:19374  
EP\_NO: 9317  
Repair Type: No Action Needed  
Crossing Status: Found  
UCIP Comments:  
FIELD\_STRUCT\_DESC: 1 of 2: 16-inch steel discharge pipe through the levee, 3.0-feet below the crown. Pump house on pile structure in drainage ditch on the landward side. Siphon breaker on the pipe on the waterward side. Service pole on pump house (Permit No. 9317-RD 819) Originally included in O+M manual 1953.  
FS Date: 4/9/2013

16-inch pipe with siphon breaker on WS shoulder.

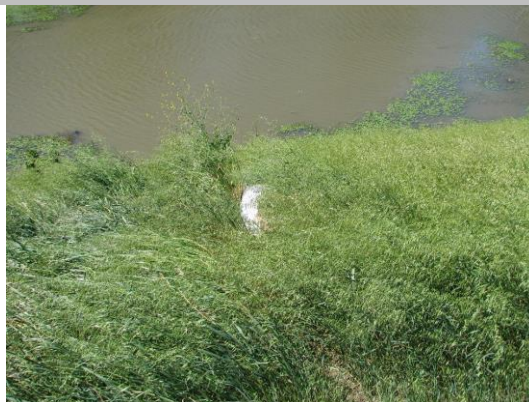
Photo 2 of 3 : UCIP\_SP\_2017\_11291\_18668.jpg

Pipe in grass on WS shoulder.
